ADVANCED COMPOSITE ELEVATOR FOR BOEING 727 AIRCRAFT VOLUME 2—FINAL REPORT

Boeing Commercial Airplane Company
P.O. Box 3707, Seattle, WA 98124

CONTRACT NAS1-14952
NOVEMBER 1980

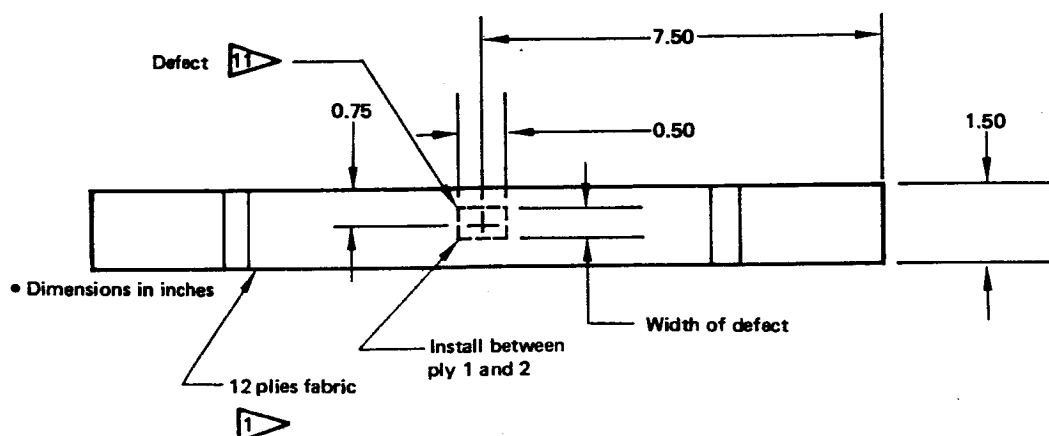
STATIC COMPRESSION WITH DELAMINATION (NASA TEST 1) (CONTINUED)

Drawing and assembly no. 2	Cloth warp orientation, deg 3	Test temperature, °F	Environment condition 4		Width of defect, in	Specimen width, in	Specimen nominal thickness, in	Failure load, kips 5	Failure stress, lbf/in ² 6	E, lbf/in ² 7	Strain, ε, in/in 8
			Wet	Dry							
65C17702-17	±45	RT		✓	0.1	1.500	0.090	4.250	31,481	3.0 x 10 ⁶	0.01049
↕	↕	↕		✓	↕	↕	↕	4.300	31,852	↕	0.01062
65C17702-17	↕	↕		✓	0.1	1.500	↕	4.320	32,000	↕	0.01067
65C17702-18	↕	↕		✓	0.3	1.502	↕	3.460	25,596	↕	0.00853
↕	↕	↕		✓	↕	1.501	↕	4.350	32,201	↕	0.01073
↕	↕	↕		✓	↕	1.500	↕	4.260	31,556	↕	0.01052
↕	↕	↕	✓		↕	1.500	↕	4.103	30,393	↕	0.01013
↕	↕	↕	✓		↕	1.501	↕	4.376	32,393	↕	0.01080
65C17702-18	↕	↕	✓		0.3	1.501	↕	4.564	33,785	↕	0.01126
65C17702-19	↕	↕		✓	0.5	1.500	↕	4.150	30,741	↕	0.01025
↕	↕	↕		✓	↕	1.502	↕	4.260	31,514	↕	0.01050
65C17702-19	±45	↕		✓	0.5	1.502	↕	4.370	32,327	3.0 x 10 ⁶	0.01078
65C17702-20	±45/0/90	↕		✓	0.1	1.504	↕	7.520	55,556	6.7 x 10 ⁶	0.00829

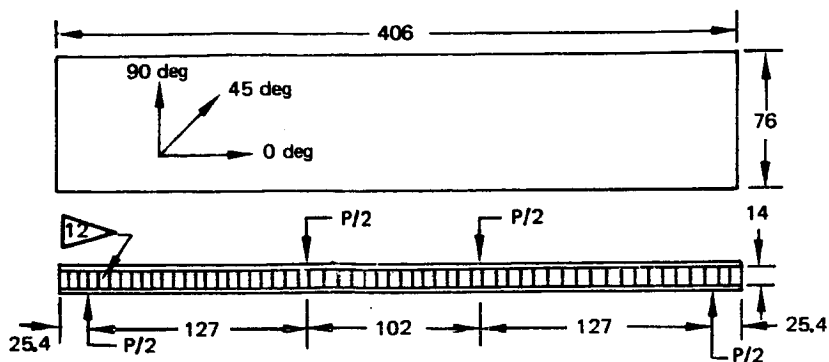
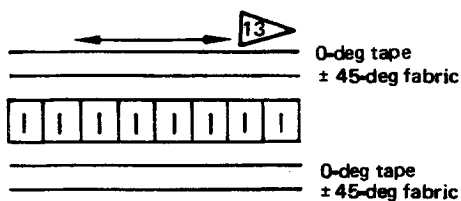
FOUR-POINT BEAM BENDING (BOEING 7313-36)

• Dimensions in mm

Test configuration 1

Drawing and assembly no. 2	Test configuration	Test temperature, °C	Environment condition 4		Actual specimen size, mm		Failure load, kN 5	Failure stress, MPa 6	E, MPa 7	Strain, ε, mm/mm 8
			Wet	Dry	Width	Thickness				
65C17727-1	1	21.1		✓	76.53	14.224	1.766	376.09	5.447x10 ⁴	0.00690
		21.1		✓	76.66	14.249	1.630	345.88		0.00635
		21.1		✓	76.58	14.224	1.657	352.65		0.00647
		-59.4	✓		75.95	14.402	1.948	412.87		0.00758
		-59.4	✓		76.35	14.453	2.039	428.35		0.00786
		82.2	✓		76.33	14.351	1.263	267.33		0.00491
		82.2	✓		76.38	14.427	1.250	262.91		0.00483
		21.1		✓	76.71	14.199	1.753	373.07		0.00685
	3	21.1		✓	76.58	14.224	1.824	388.15	5.447x10 ⁴	0.00713
		21.1		✓	76.68	14.224	1.861	395.68		0.00726
		-59.4	✓		76.48	14.529	2.260	471.27		0.00865
		-59.4	✓		76.45	14.478	1.808	378.58		0.00695
		82.2	✓		76.38	14.427	1.108	232.97		0.00428
		82.2	✓		76.48	14.453	1.143	239.70		0.00440

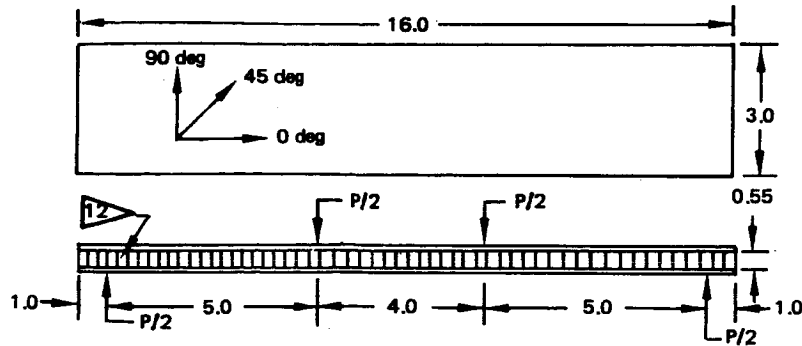
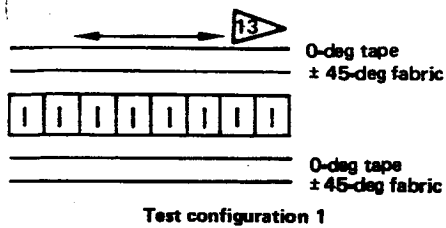
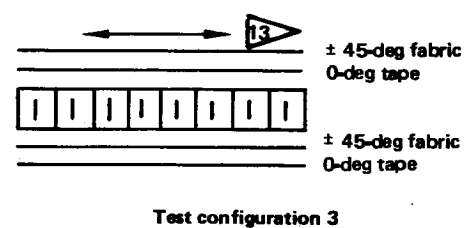
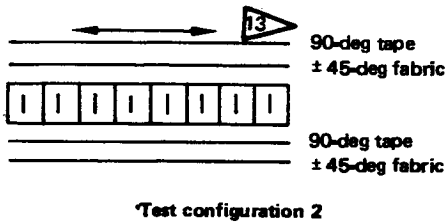
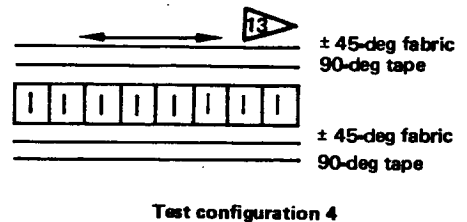
FOUR-POINT BEAM BENDING (BOEING 7313-36) (CONTINUED)

• Dimensions in inches

• Fabric and tape

Drawing and assembly no. 2	Test configuration	Test temperature, °F	Environment condition 4		Actual specimen size, in		Failure load, lbf 5	Failure stress, lbf/in ² 6	E, lbf/in ² 7	Strain, ε, in/in 8
			Wet	Dry	Width	Thickness				
65C17727-1	1	RT		✓	3.013	0.560	397.0	54,546	7.9 × 10 ⁶	0.00690
				✓	3.019	0.561	366.5	50,164		0.00635
		RT		✓	3.015	0.560	372.5	51,146		0.00647
		-75	✓		2.990	0.567	438.0	59,879		0.00758
		-75	✓		3.006	0.569	458.5	62,125		0.00786
		180	✓		3.005	0.565	284.0	38,771		0.00491
		180	✓		3.007	0.568	281.0	38,130		0.00483
		RT		✓	3.020	0.555	394.0	54,107		0.00685
		RT		✓	3.015	0.560	410.0	56,295		0.00713
		RT		✓	3.019	0.560	418.5	57,386		0.00726
65C17727-1	3	-75	✓		3.011	0.572	508.0	68,350		0.00865
		-75	✓		3.010	0.570	406.5	54,907		0.00695
		180	✓		3.007	0.568	249.0	33,788		0.00428
		180	✓		3.011	0.569	257.0	34,764	7.9 × 10 ⁶	0.00440

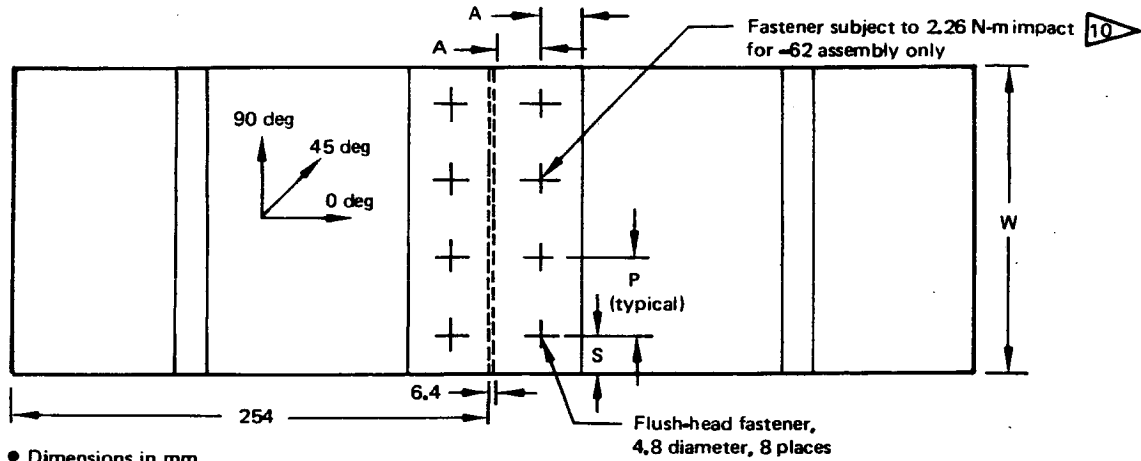
MECHANICAL FASTENED JOINT (NASA TEST 4)

• Dimensions in mm

• Splice plate thickness

Drawing and assembly no. 2	Cloth warp orientation, deg 3	Test temperature, °C	Environment condition 4		A, mm	S, mm	P, mm	Specimen width, mm	Specimen nominal thickness, mm	Failure load, kN 5	Bearing failure stress, MPa 14	E, MPa 7	Comments
			Wet	Dry									
65C17702-49	±45/0/90	21.1		✓	7.4	7.4	14.5	57.9	2.286	40.210	461.71	4.62 x 10 ⁴	Net tension failure
				✓						38.964	447.41		
65C17702-49				✓		7.4	14.5	57.9		42.879	492.35		Net tension failure
65C17702-50				✓		12.2	24.1	96.5		39.498	453.54		Shear out failure
				✓				96.6		42.923	492.86		
				✓				96.6		41.277	473.99		
			✓					96.8		42.256	485.20		
			✓							45.014	516.87		
65C17702-50			✓			12.2	24.1	96.8		40.210	461.71		
65C17702-51				✓		17.0	33.8	135.0		40.121	460.69		
				✓				135.4		38.431	441.28		
65C17702-51				✓	7.4	17.0	33.8	135.1		38.342	440.26		Shear out failure
65C17702-52				✓	12.2	7.4	14.5	58.0		42.523	488.27		Net tension failure

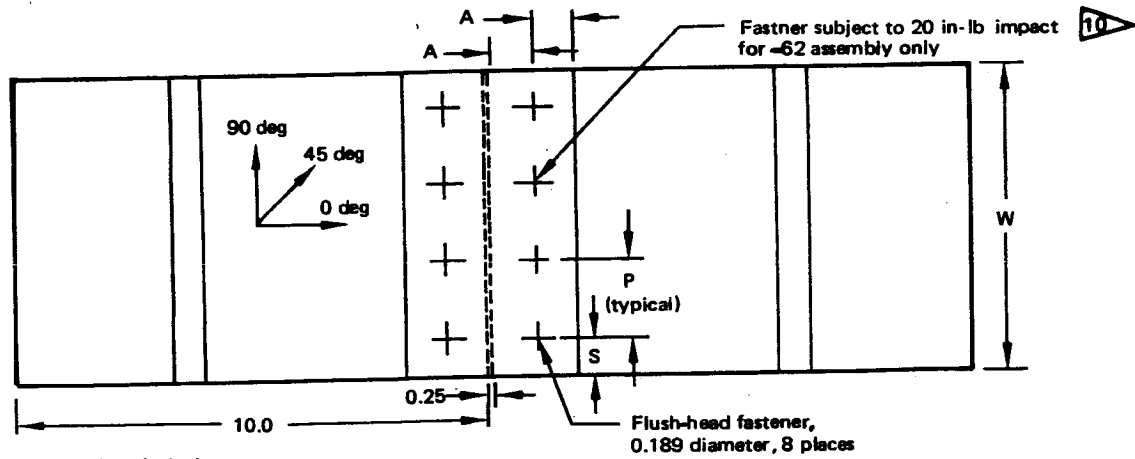
MECHANICAL FASTENED JOINT (NASA TEST 4) (CONTINUED)

• Dimensions in inches

• Splice plate thickness

Drawing and assembly no. 2	Cloth warp orientation, deg 3	Test temperature, °F	Environment condition 4		A, in	S, in	P, in	Specimen width, in	Specimen nominal thickness, in	Failure load, kips 5	Bearing failure stress, lbf/in ² 14	E, lbf/in ² 7	Comments
			Wet	Dry									
65C17702-49	±45/0/90	RT		✓	0.29	0.29	0.57	2.280	.090	9.040	66,963	6.7 X 10 ⁶	Net tension failure
↑	↑	↑		✓	↑	↑	↑	2.278	↑	8.760	64,889	↑	↑
65C17702-49				✓		0.29	0.57	2.280		9.640	71,407		Net tension failure
65C17702-50				✓		0.48	0.95	3.800		8.880	65,778		Shear out failure
↑				✓		↑	↑	3.802		9.650	71,481		↑
				✓				3.803		9.280	68,741		
			✓					3.810		9.500	70,370		
↓			✓					3.810		10.120	74,963		
65C17702-50			✓			0.48	0.95	3.810		9.040	66,963		
65C17702-51				✓		0.67	1.33	5.314		9.020	66,815		
↑				✓		↑	↑	5.329		8.640	64,000		↓
65C17702-51				✓	0.29	0.67	1.33	5.318		8.620	63,852		Shear out failure
65C17702-52				✓	0.48	0.29	0.57	2.283		9.560	70,815		Net tension failure

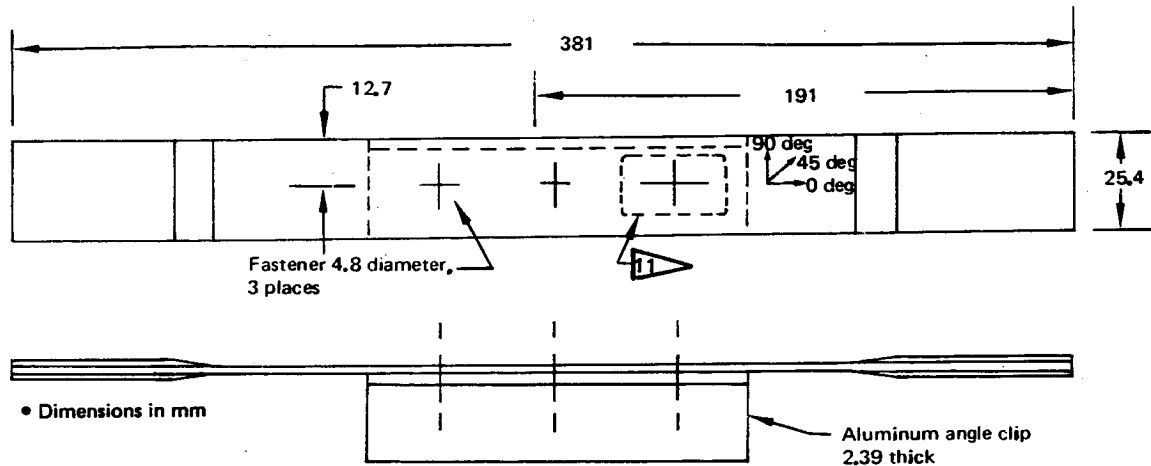
STATIC TENSION, HARD POINT (NASA TEST 4)

- Laminate thickness
 - -15-8 plies fabric 1
 - -16 through -19-12 plies fabric 1
- Flush-head fastener - -15, -16, and -18
- Protruding-head fastener - -17 and -19
- Teflon 11 7.6 x 12.7 mm - -18 and -19

Drawing and assembly no. 2	Cloth warp orientation, deg 3	Test temperature, °C	Environment condition 4		Specimen width, mm	Specimen nominal thickness, mm	Failure load, kN 5	Failure stress, MPa 6	E, MPa 7	Strain, ε, mm/mm 8
			Wet	Dry						
65C17706-15	±45/0/90	21.1		✓	25.6	1.524	8.785	224.44	4,620 × 10 ⁴	0.00487
↑	↑	↑		↑	25.6	↑	8.896	228.01	↑	0.00494
65C17706-15	↑	↑		↑	25.7	1.524	8.807	225.28	↑	0.00488
65C17706-16	↑	↑		↑	25.4	2.286	12.032	207.44	↑	0.00449
↑	↑	↑		↑	25.3	↑	11.921	205.73	↑	0.00445
65C17706-16	↑	↑		↑	25.4	↑	12.365	213.19	↑	0.00461
65C17706-17	↑	↑		↑	25.3	↑	13.188	227.60	↑	0.00493
↑	↑	↑		↑	↑	↑	12.276	212.08	↑	0.00459
65C17706-17	↑	↑		↑	↑	↑	13.033	225.15	↑	0.00487
65C17706-18	↑	↑		↑	25.3	↑	12.864	222.01	↑	0.00481
↑	↑	↑		↑	25.4	↑	12.303	212.12	↑	0.00459
65C17706-18	↑	↑		↑	↑	↑	12.810	220.86	↑	0.00478
65C17706-19	↑	↑		↑	25.4	↑	14.652	252.36	↑	0.00546
↑	↑	↑		↑	25.3	↑	13.077	225.69	↑	0.00489
65C17706-19	±45/0/90	21.1		✓	25.3	2.286	14.145	244.11	4,620 × 10 ⁴	0.00528

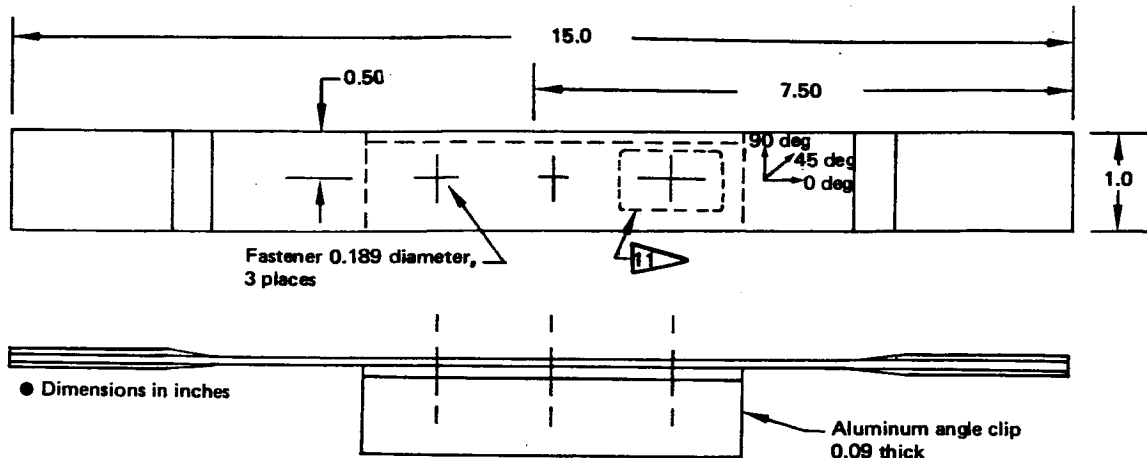
STATIC TENSION, HARD POINT (NASA TEST 4) (CONTINUED)

- Laminate thickness
 - -15-8 plies fabric
 - -16 through -19-12 plies fabric
- Flush-head fastener-- -15, -16, and -18
- Protruding-head fastener-- -17 and -19
- Teflon 0.30 x 0.50 in-- -18 and -19

Drawing and assembly no. 2	Cloth warp orientation, deg 3	Test temperature, °F	Environment condition 4		Specimen width, in	Specimen nominal thickness, in	Failure load, kips 5	Failure stress, lbf/in ² 6	E, lbf/in ² 7	Strain, ε, in/in 8
			Wet	Dry						
65C17706-15	±45/0/90	RT		✓	1.009	0.060	1.975	32,623	6.7 x 10 ⁶	0.00487
65C17706-15					1.008		2.000	33,069		0.00494
65C17706-15					1.010	0.060	1.980	32,673		0.00488
65C17706-16					0.999	0.090	2.705	30,086		0.00449
65C17706-16					0.998		2.680	29,837		0.00445
65C17706-16					0.999		2.780	30,920		0.00461
65C17706-17					0.998		2.965	33,010		0.00493
65C17706-17					0.997		2.760	30,759		0.00459
65C17706-17					0.997		2.930	32,654		0.00487
65C17706-18					0.998		2.892	32,198		0.00481
65C17706-18					0.999		2.766	30,764		0.00459
65C17706-18					0.999		2.880	32,032		0.00478
65C17706-19					1.000		3.294	36,600		0.00546
65C17706-19					0.998		2.940	32,732		0.00489

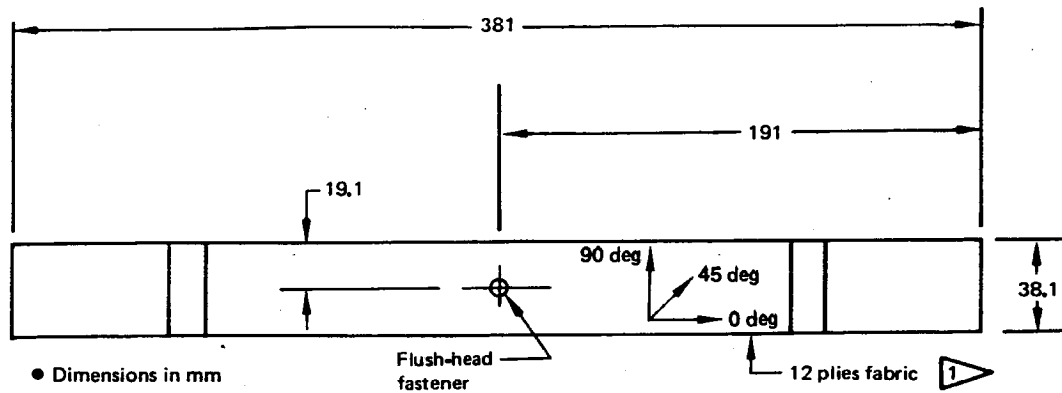
STATIC TENSION, FILLED HOLE (NASA TEST 4)

- Dimensions in mm
- Fasteners
 - 4.8 diameter— -20
 - 6.35 diameter— -21
 - 7.9 diameter— -22

Drawing and assembly no. 2	Cloth warp orientation, deg 3	Test temperature, °C 4	Environment condition 4		Specimen width, mm	Specimen nominal thickness, mm	Failure load, kN 5	Failure stress, MPa 6	E, MPa 7	Strain, ϵ , mm/mm 8
			Wet	Dry						
65C17706-20	±45/0/90	21.1		✓	38.23	2.286	21 199	242.61	4.620×10^4	0.00525
↑	↑	↑		✓	38.20	↑	21.110	241.75	↑	0.00523
65C17706-20				✓	38.18		22.093	253.18		0.00548
65C17706-21				✓	38.15		19.473	223.30		0.00483
↑				✓	38.05		18.690	214.90		0.00465
↑				✓	38.10		20.550	235.96		0.00511
↓			✓		38.13		20.995	240.91		0.00521
↓			✓		38.15		21.840	250.44		0.00542
65C17706-21			✓		38.23		21.128	241.79		0.00523
65C17706-22				✓	38.13		17.516	201.00		0.00435
↑				✓	38.20	↓	18.659	213.68	↓	0.00463
65C17706-22	±45/0/90	21.1		✓	38.07	2.286	19.749	226.92	4.620×10^4	0.00491

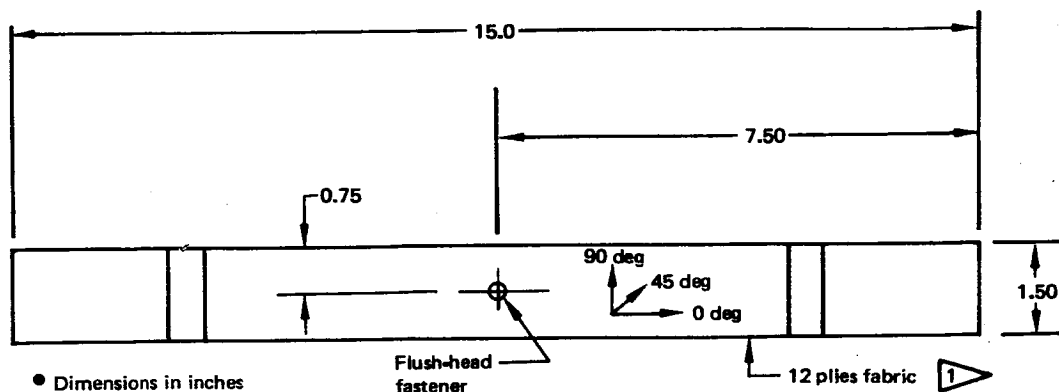
STATIC TENSION, FILLED HOLE (NASA TEST 4) (CONTINUED)

- Dimensions in inches
- Fasteners
 - 0.189 diameter— -20
 - 0.25 diameter— -21
 - 0.313 diameter— -22

Drawing and assembly no. 2	Cloth warp orientation, deg 3	Test temperature, °F	Environment condition 4		Specimen width, in	Specimen nominal thickness, in	Failure load, kips 5	Failure stress, lbf/in ² 6	E, lbf/in ² 7	Strain, ϵ , in/in 8
			Wet	Dry						
65C17706-20	±45/0/90	RT		✓	1.505	0.090	4.766	35,186	6.7×10^6	0.00525
↑	↑	↑		✓	1.504	↑	4.746	35,062	↑	0.00523
65C17706-20				✓	1.503		4.967	36,719		0.00548
65C17706-21				✓	1.502		4.378	32,386		0.00483
↑				✓	1.498		4.202	31,167		0.00465
				✓	1.500		4.620	34,222		0.00511
			✓		1.501		4.720	34,940		0.00521
↓			✓		1.502		4.910	36,322		0.00542
65C17706-21			✓		1.505		4.750	35,068		0.00523
65C17706-22				✓	1.501		3.938	29,151		0.00435
↑	↓	↓		✓	1.504	↓	4.195	30,991	↓	0.00463
65C17706-22	±45/0/90	RT		✓	1.499	0.090	4.440	32,911	6.7×10^6	0.00491

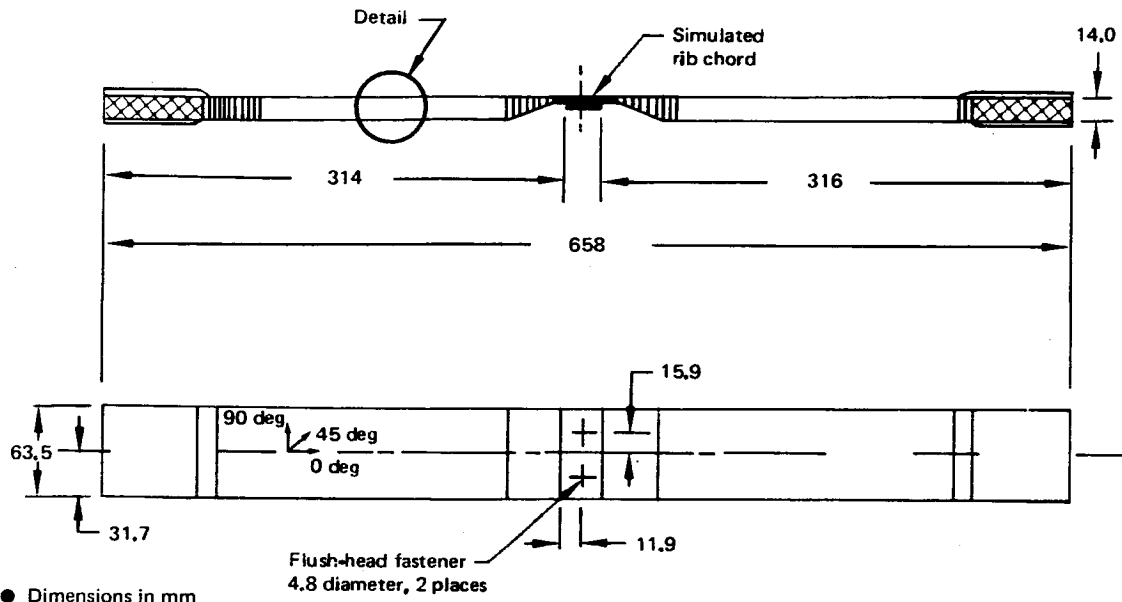
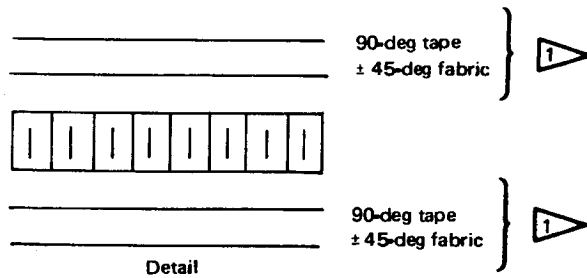
STATIC TENSION, PANEL TO RIB (NASA TEST 8)

Drawing and assembly no. 2	Test temperature, °C	Environment condition 4		Specimen width, mm	Specimen nominal thickness, mm	Failure load, kN 5	Failure stress, MPa 6	E, MPa 7	Strain, ε, mm/mm 8
		Wet	Dry						
65C17708-1	21.1		✓	63.50	0.559	5.249	147.93	2.620 × 10 ⁴	0.00565
↑	↑		✓	↑	↑	5.471	154.20	↑	0.00589
↑	↑		✓	↑	↑	7.784	219.39	↑	0.00837
↑	↑		✓	↑	↑	6.672	188.05	↑	0.00718
↑	↑		✓	↑	↑	6.850	193.06	↑	0.00737
↓	↓	✓		↓	↓	8.273	233.18	↓	0.00890
↓	↓	✓		↓	↓	7.828	220.64	↓	0.00842
65C17708-1	21.1	✓		63.50	0.559	6.850	193.06	2.620 × 10 ⁴	0.00737

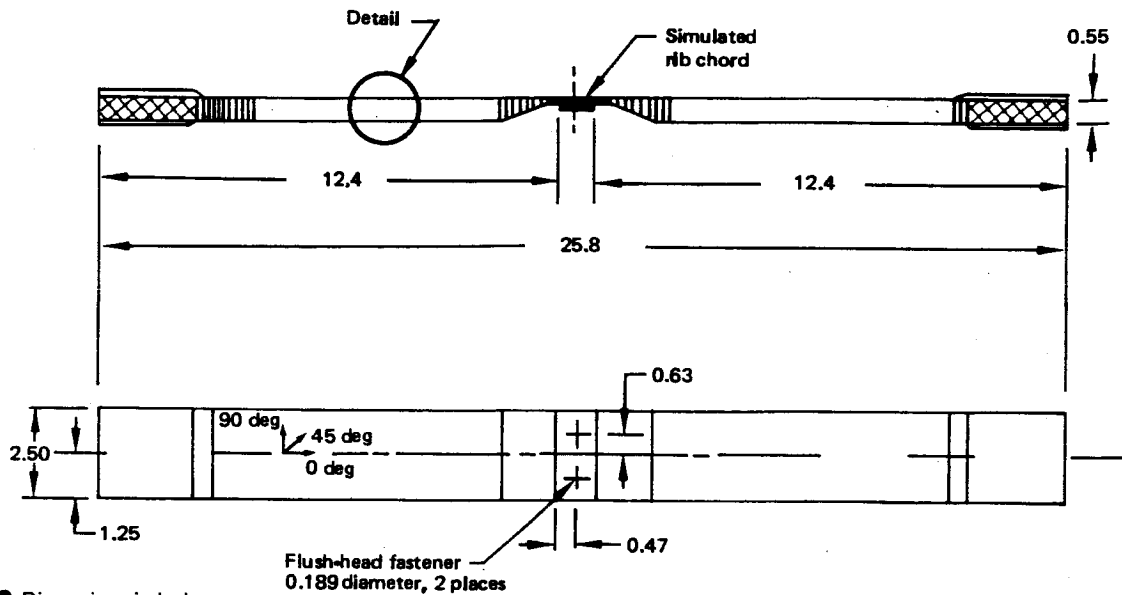
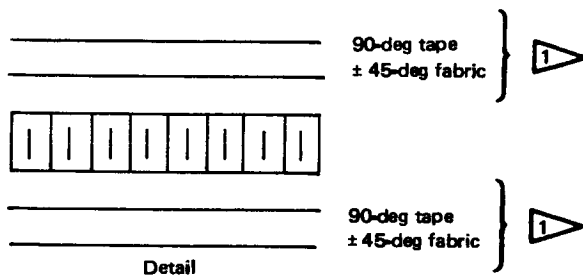
STATIC TENSION, PANEL TO RIB (NASA TEST 8) (CONTINUED)

Drawing and assembly no. 2	Test temperature, °F	Environment condition 4		Specimen width, in	Specimen nominal thickness, in	Failure load, kips 5	Failure stress, lbf/in ² 6	E, lbf/in ² 7	Strain, ε, in/in 8
		Wet	Dry						
65C17708-1	RT		✓	2.500	0.022	1.18	21,455	3.8 × 10 ⁶	0.00565
↑	↑		✓	↑	↑	1.23	22,364	↑	0.00589
↑	↑		✓	↑	↑	1.75	31,818	↑	0.00837
↑	↑		✓	↑	↑	1.50	27,273	↑	0.00718
↑	↑		✓	↑	↑	1.54	28,000	↑	0.00737
↓	↓	✓		↓	↓	1.86	33,818	↓	0.00890
↓	↓	✓		↓	↓	1.76	32,000	↓	0.00842
65C17708-1	RT	✓		2.500	0.022	1.54	28,000	3.8 × 10 ⁶	0.00737

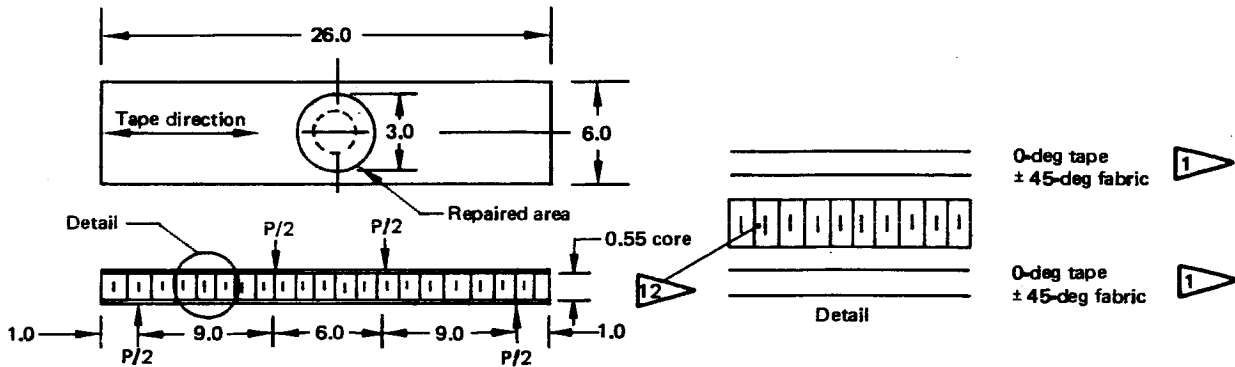
HONEYCOMB PANEL REPAIR TESTS (CONTINUED)

• Dimensions in inches

Drawing and assembly no. 2	Test temperature, °F	Environment condition 4		Failure load, lb 5	Failure stress, lb/in ² 6	E, lbf/in ² 7	Strain, ε, in/in 8	Comments
		Wet	Dry					
65C17721-4	70		✓	387	47034	7.9 x 10 ⁶	0.00595	Baseline specimen
			✓	367	44604		0.00565	
			✓	400	48614		0.00615	
		✓		372	45211		0.00572	
		✓		371	45090		0.00571	
		✓		379	46062		0.00583	Baseline specimen
			✓	344	41808		0.00529	Specimen impacted with 10 in-lb damage
			✓	340	41322		0.00523	
			✓	323	39256		0.00497	
		✓		309	37555		0.00475	
		✓		309	37555		0.00475	Specimen impacted with 10 in-lb damage
65C17721-4	70	✓		339	41201		0.00522	
65C17721-2	-65		✓	564	68546		0.00868	Repaired specimen
			✓	548	66802		0.00843	
	-65		✓	629	76446		0.00968	
	70		✓	420	51045		0.00646	
			✓	456	55420		0.00702	
	70		✓	439	53354		0.00675	
	160		✓	332	40350		0.00511	
			✓	359	43631		0.00552	
	160		✓	389	47278		0.00598	
	-65	✓		577	70126		0.00888	
		✓		374	45454		0.00575

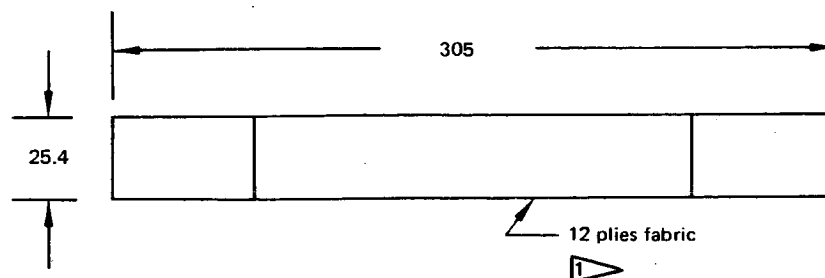
ENVIRONMENTAL EXPOSURE, TENSION, LAMINATE COUPON (NASA TEST 3)

• Dimensions in mm

Drawing and assembly no. 2	Cloth warp orientation, deg 3	Exposure condition	Test temper- ature, °C	Actual specimen size, mm		Effective area, mm ²	Failure load, kN 5	Failure stress, MPa 6	E, MPa 7	Strain, ε, mm/mm 8
				Width	Thickness					
65C17703-1	± 45	Zero time	21	25.50	2.29	58.29	10.898	186.96	2.07 x 10 ⁴	0.00903

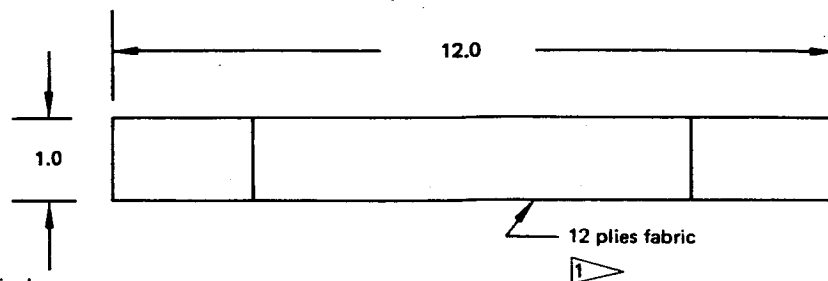
ENVIRONMENTAL EXPOSURE, TENSION, LAMINATE COUPON (NASA TEST 3) (CONTINUED)

● Dimensions in inches

Drawing and assembly no. 2	Cloth warp orientation, deg 3	Exposure condition	Test temperature, °F	Actual specimen size, in		Effective area, in ²	Failure load, lbf 5	Failure stress, lbf/in ² 6	E, lbf/in ² 7	Strain, ε, in/in 8
				Width	Thickness					
65C17703-1	± 45	Zero time	70	1.004	0.090	0.0904	2450	27,102	3.0 x 10 ⁶	0.00903

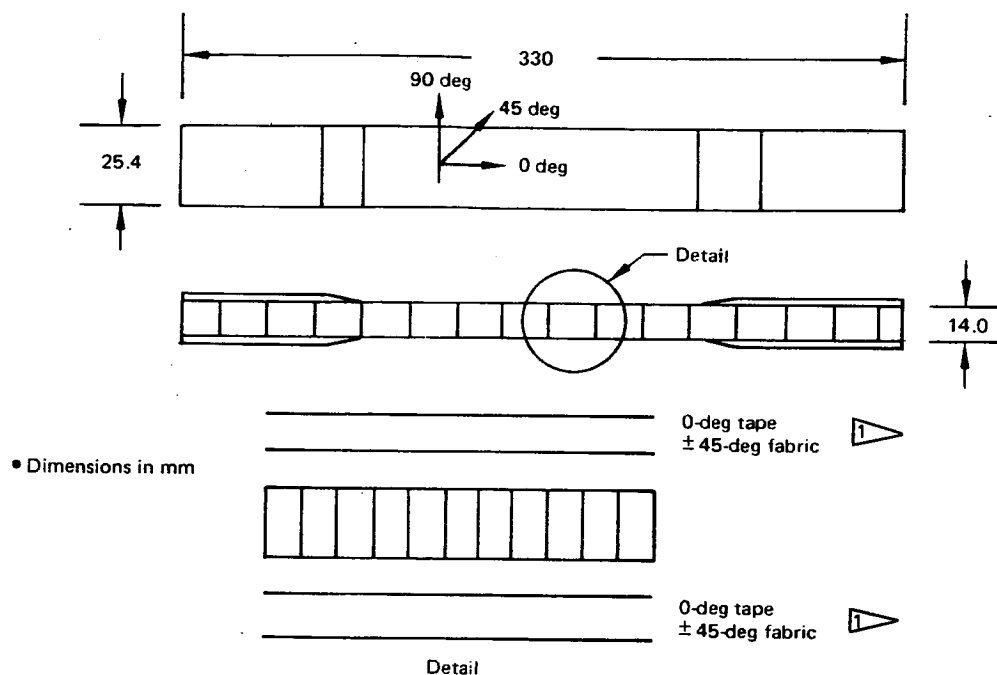
ENVIRONMENTAL EXPOSURE, COMPRESSION, HONEYCOMB COUPON (NASA TEST 3)

Drawing and assembly no. 2	Exposure condition	Test temperature, °C	Actual specimen size, mm		Effective area, mm ²	Failure load, kN 5	Failure stress, MPa 6	E, MPa 7	Strain, ε, mm/mm 8
			Width	Thickness					
65C17703-4	Zero time	21	27.03	0.559	15.10	3.047	201.78	2.62 × 10 ⁴	0.00770
			27.28		15.24	3.238	212.47		0.00811
			26.92		15.04	3.581	238.10		0.00908
			27.48		15.35	3.696	240.78		0.00919
65C17703-4			26.92		15.04	3.029	201.40		0.00768
65C17703-20	12 months		27.15		15.18	3.460	227.93		0.00870
	outdoor		27.03		15.11	3.981	263.47		0.01006
	rack		27.03		15.11	3.874	256.39		0.00979
65C17703-20		21	26.80	0.559	14.98	3.821	255.06	2.62 × 10 ⁴	0.00974

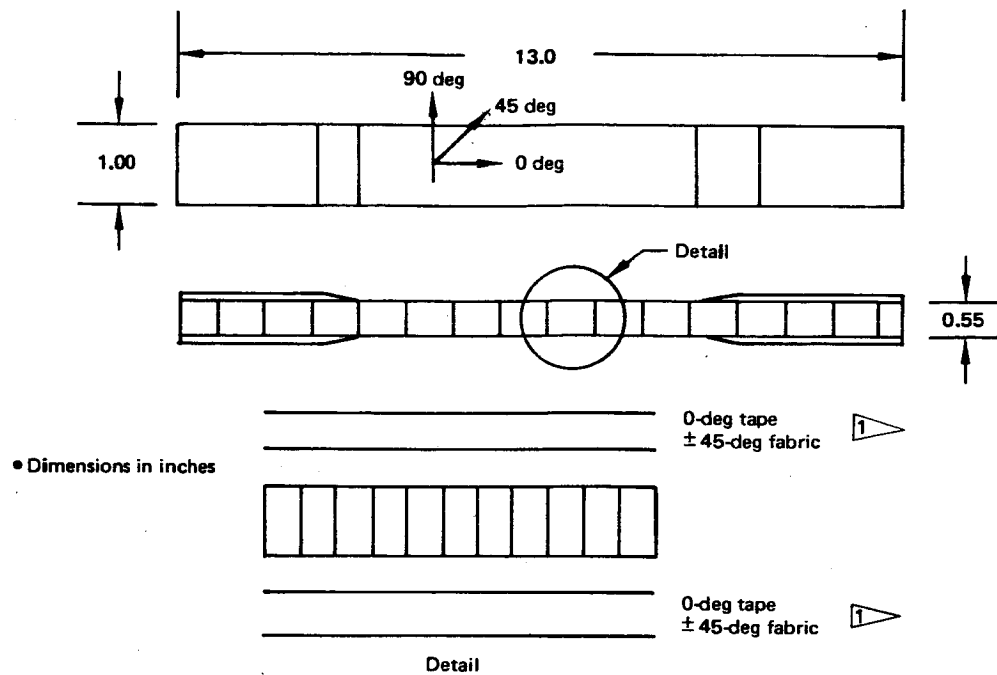
ENVIRONMENTAL EXPOSURE, COMPRESSION, HONEYCOMB COUPON (NASA TEST 3) (CONTINUED)

Drawing and assembly no. 2	Exposure condition	Test temperature, °F	Actual specimen size, in		Effective area, in ²	Failure load, lbf 5	Failure stress, lbf/in ² 6	E, lbf/in ² 7	Strain, ε, in/in 8
			Width	Thickness					
65C17703-4	Zero time	70	1.064	0.022	0.02341	685.0	29,261	3.8 × 10 ⁶	0.00770
			1.074		0.02363	728.0	30,808		0.00811
			1.060		0.02332	805.0	34,520		0.00908
			1.082		0.02380	831.0	34,916		0.00919
65C17703-4			1.060		0.02332	681.0	29,202		0.00768
65C17703-20	12 months		1.069		0.02352	778.0	33,078		0.00870
	outdoor		1.064		0.02341	895.0	38,232		0.01006
	rack		1.064		0.02341	871.0	37,206		0.00979
65C17703-20		70	1.055	0.022	0.02321	859.0	37,010	3.8 × 10 ⁶	0.00974
